# TOP ANTENNA WASHOUT?

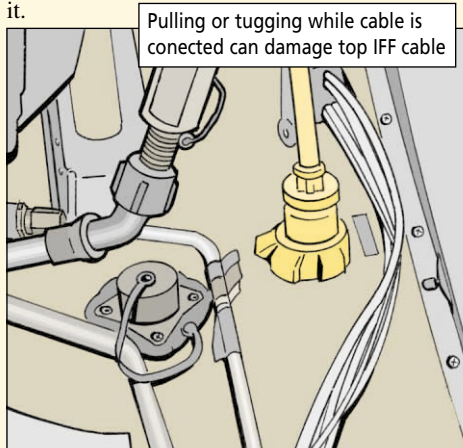
Anytime you wash your Kiowa Warrior with the forward cowling removed, remember to cover the top IFF antenna receptacle. If you forget, water gets in and can short out the antenna when you reinstall it.

That means you'll get a NO-GO reading on the MFD (multi-functional display) when you do your pre-flight checks. A NO-GO means your aircraft isn't ready to identify itself to other aircraft and ground facilities.

'Course, a NO-GO could also flash if you're too rough removing the cowling while the cable is still attached. Any pulling or tugging can damage the IFF cable. So check the cable and the connector pin for damage if you get a NO-GO.

Still get NO-GO after washing?  
Troubleshoot IFF antenna

If you get the NO-GO readout only after you've washed the bird, put a small amount of isopropyl alcohol, NSN 6810-00-286-5435, in the antenna receptacle. That will dry up the excess water. Or use a blast of shop air to blow out the water.

Once it's dried out, do another operational check on the top IFF antenna to make sure it's working. If it still won't work, troubleshoot the IFF antenna system.
